Fire Performance of a Laterally Loaded Light Timber-framed Compartment

*A thesis submitted in partial fulfilment of the requirements for
the degree of Master of Engineering in Fire Engineering*

Department of Civil and Natural Resources Engineering

University of Canterbury

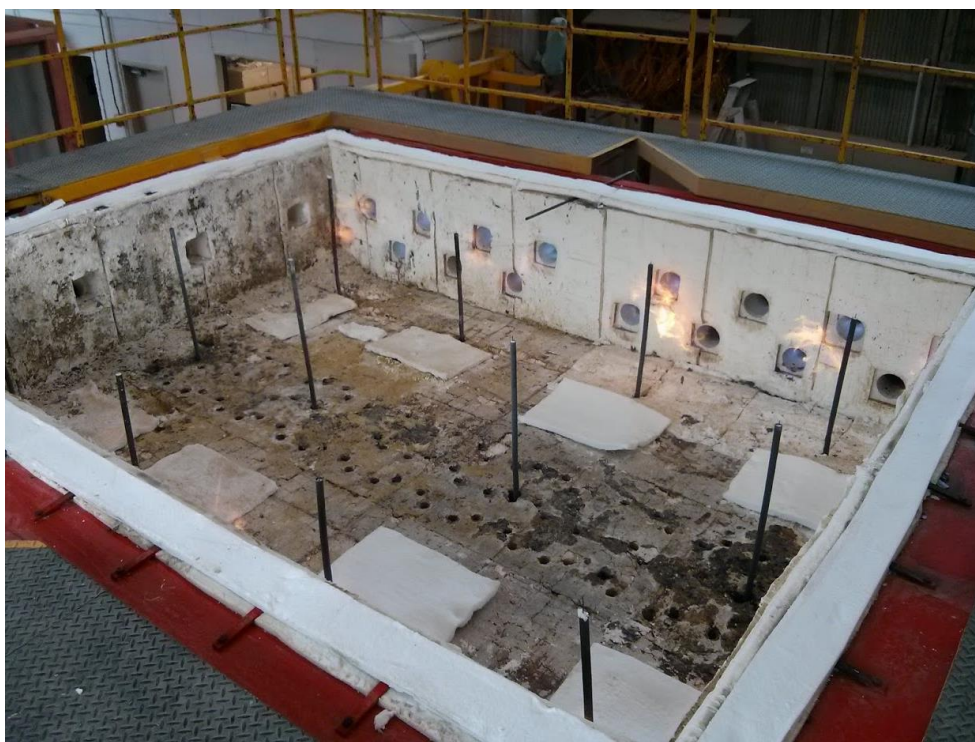
Figure 2-2 – BRANZ furnace in horizontal orientation with burners firing

In New Zealand the most common method for obtaining FRRs is by full-scale testing (Nyman, 2002). Tests are carried out at the Building Research Association of New Zealand (BRANZ) fire laboratory located in Judgeford, Porirua, New Zealand. The facility has a full-scale furnace that can be orientated either horizontally or vertically. The furnace is capable of testing specimens that fit onto a frame with an opening of approximately 4 m × 3 m and has been used to test floor, wall and door constructions (among others). BRANZ carries out testing to AS 1530 Part 4 (SAA, 2005), ISO 834 (ISO, 1999) or BS 476 Parts 20-23 (BSI, 1987) as required. There is similarity in the methods of testing and requirements of these standards (Nyman, 2002). Figure 2-2 shows the full-scale furnace at BRANZ in the horizontal orientation.

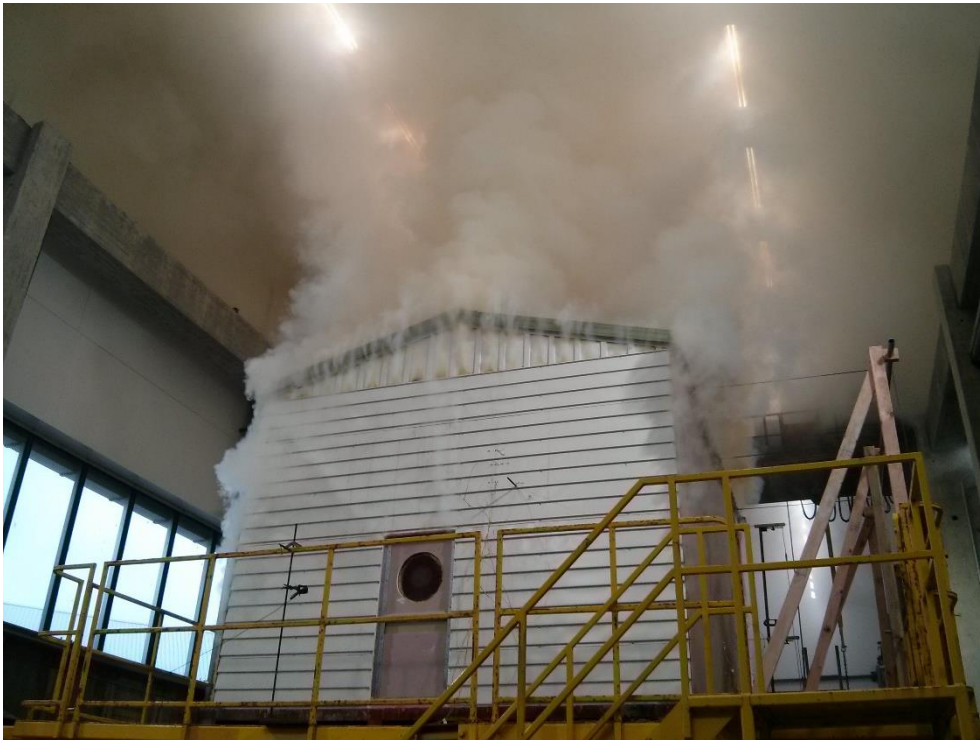
Figure 5-52 - Experiment #1 photo of fixed end wall soon after ceiling system failed (approximately 16 min)

The main observations during the first 10 min of the experiment were increasing quantities of rising steam from the compartment, condensation forming on the outside face of the metal cladding, and no detectable deflection in the fire-rated wall. Approximately 16 min into the experiment, the plasterboard ceiling failed. This was accompanied by significant increases in the quantity of steam and smoke rising from the compartment as shown in Figure 5-52.

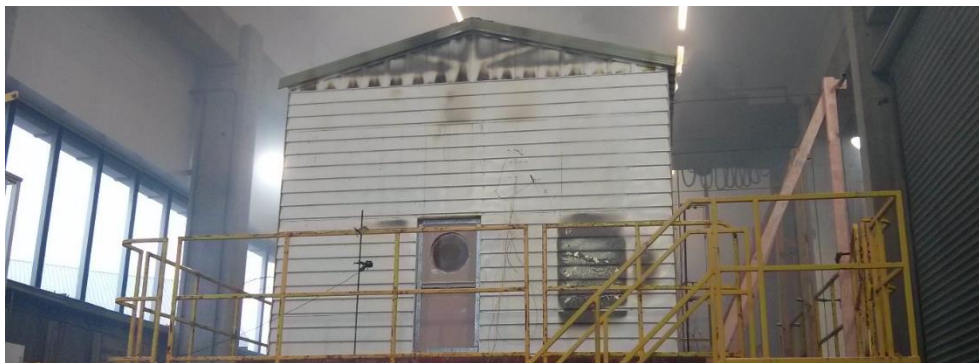
Figure 5-55 – Experiment #1 photo showing evidence of lining failure on lower portion of end wall at 25 min

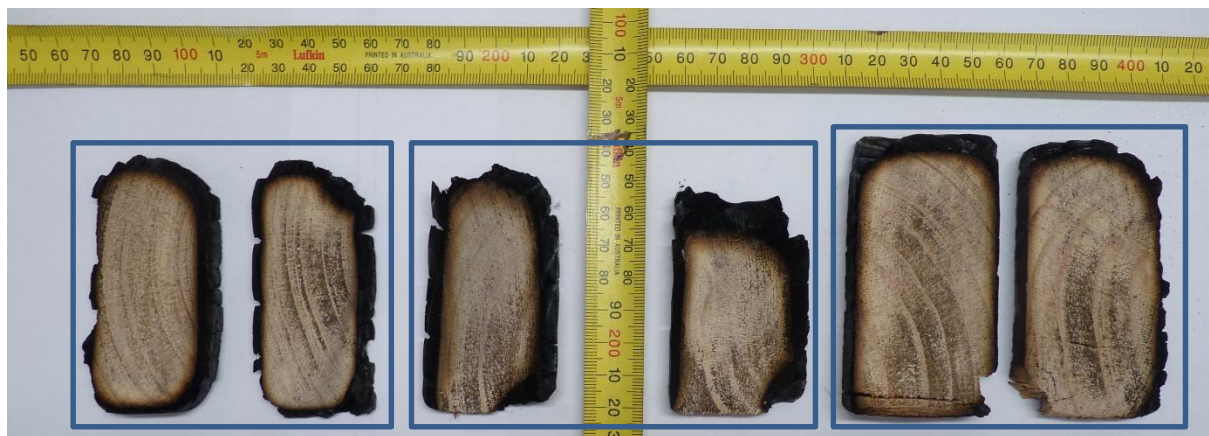
Figure 5-58 – Experiment #1 example of stud charring from three studs

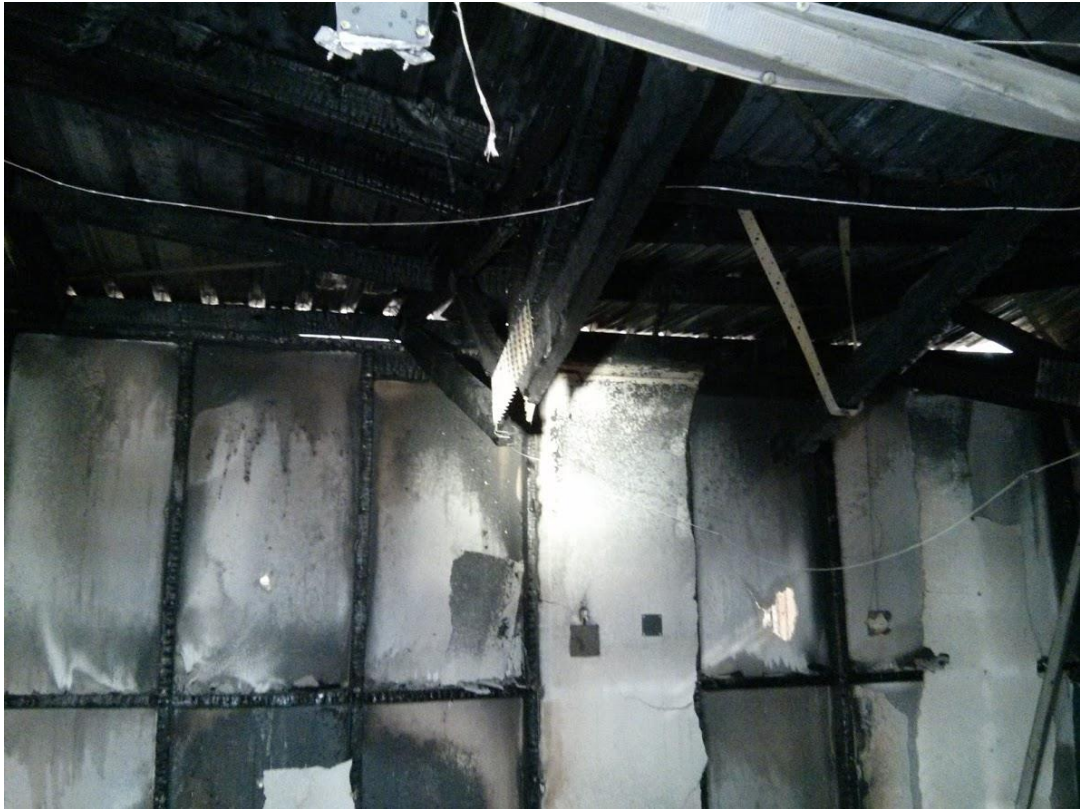
Figure 5-62 – Experiment #1 photo of centre truss (T3) failure after experiment

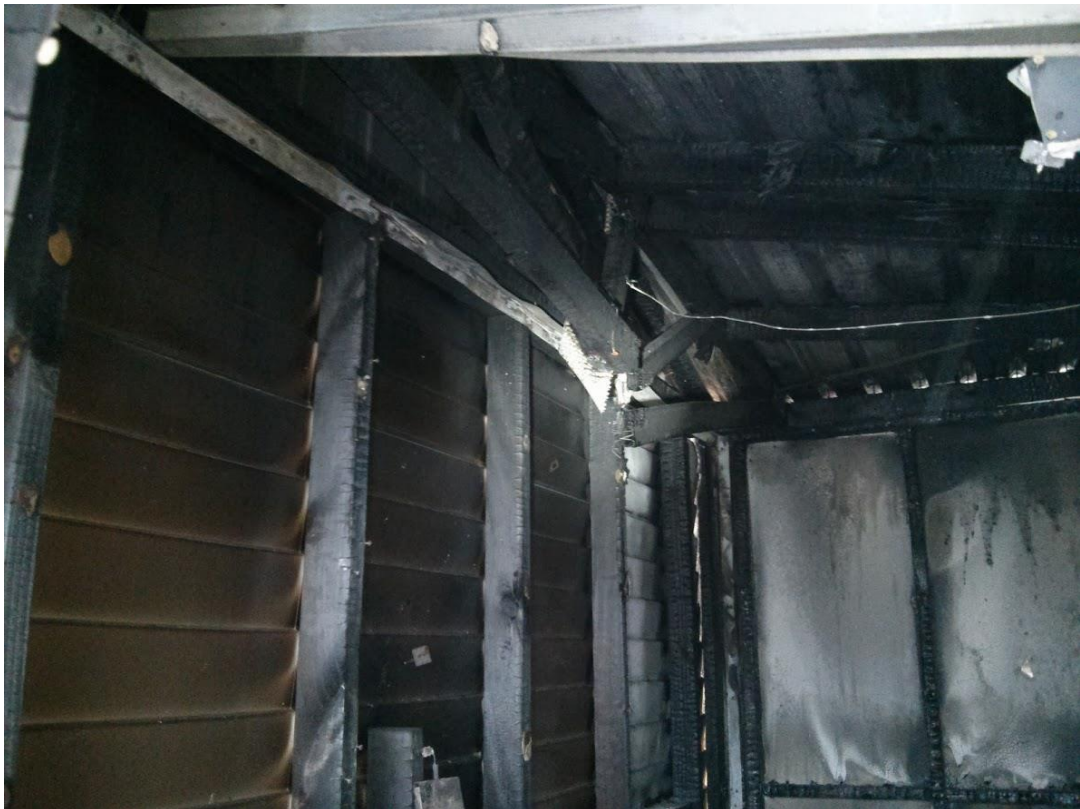
Figure 5-63 – Experiment #1 photo of free end truss (T4) failure after experiment

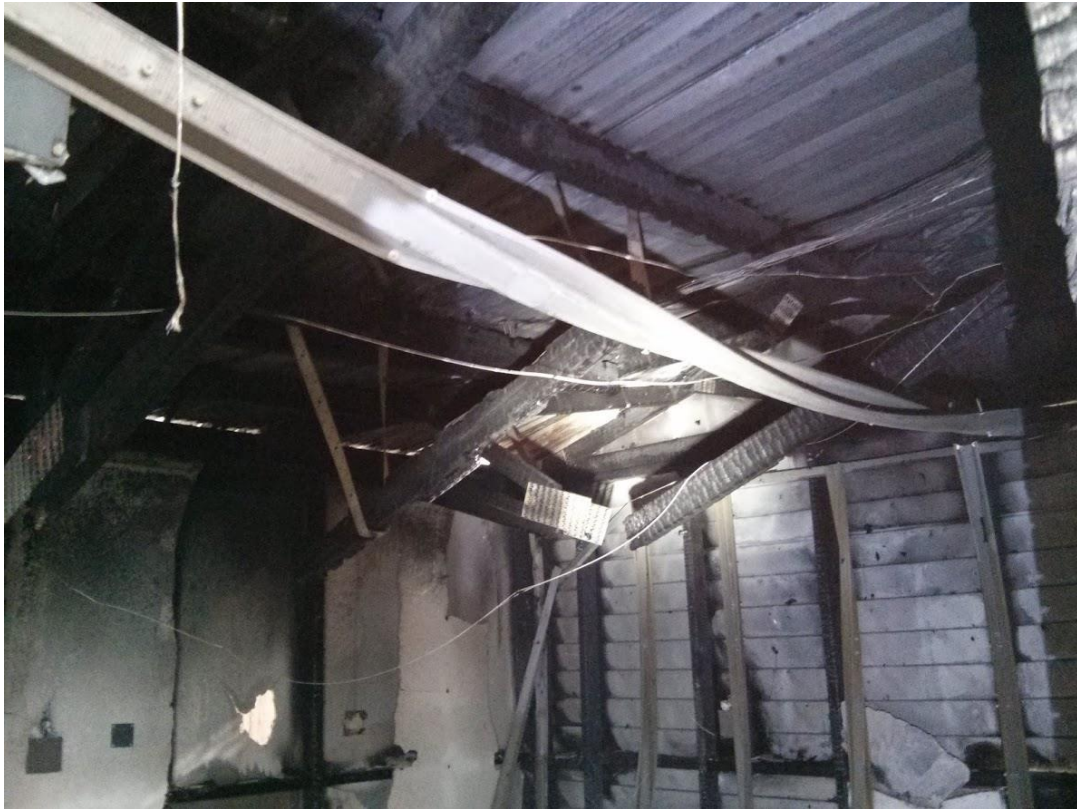
Figure 5-64 – Experiment #1 photo of fixed end truss (T2) failure after experiment

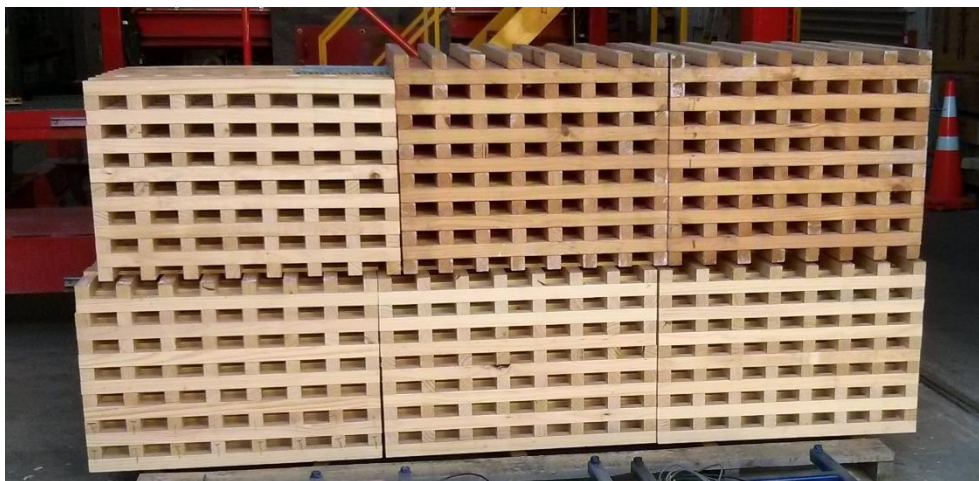
Figure 6-15 – Photo of wood cribs used for Experiment #2, top two on right hand side are the existing cribs from BRANZ, and the remaining four are the new cribs

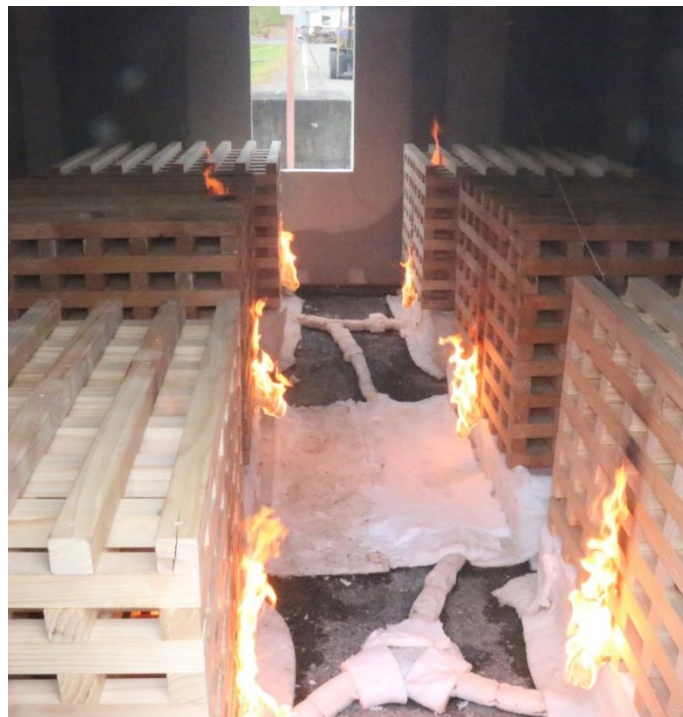
Figure 6-45 - Experiment #2 wood cribs after ignition, burning wicks visible

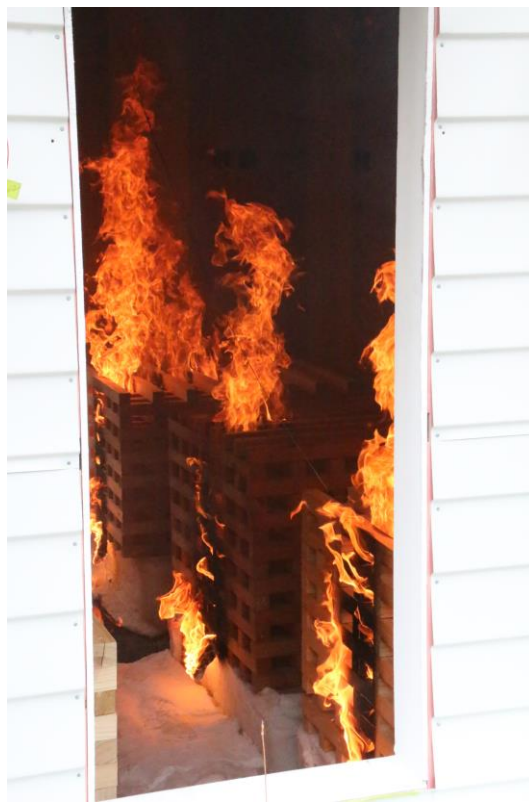
Figure 6-46 - Experiment #2 view of cribs during initial fire growth, $t \approx 3$ min

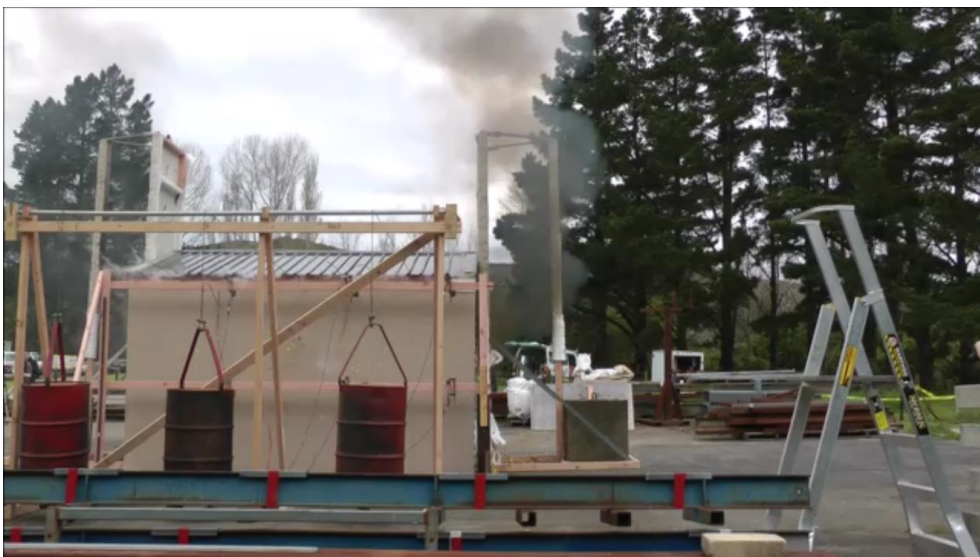
Figure 6-48 - Experiment #2, view of fire-rated wall after 10 min

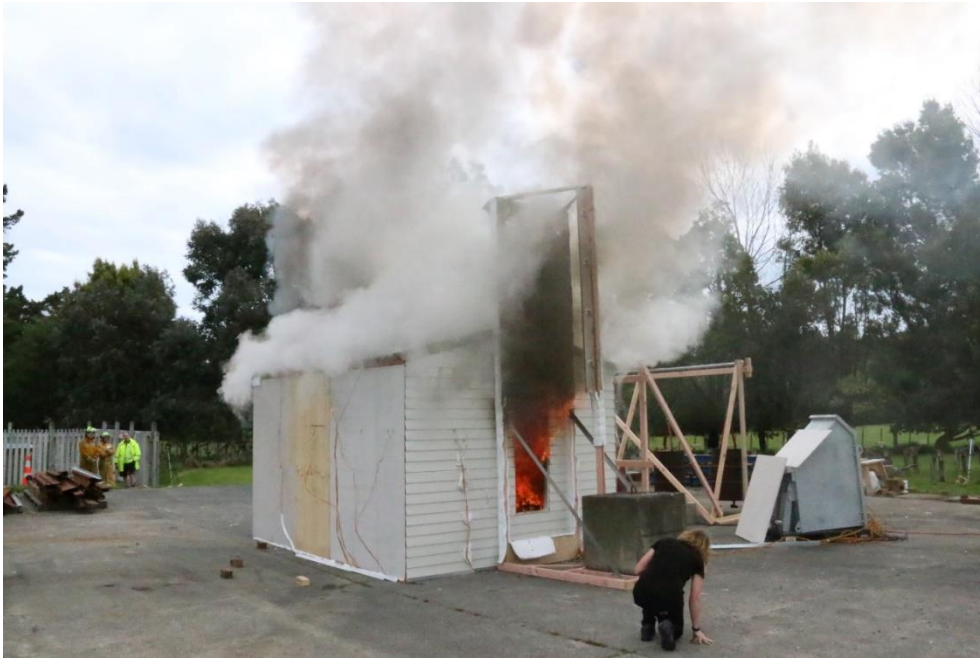
Figure 6-49 - Experiment #2 photo of compartment near time of ceiling failure, $t \approx 13$ min

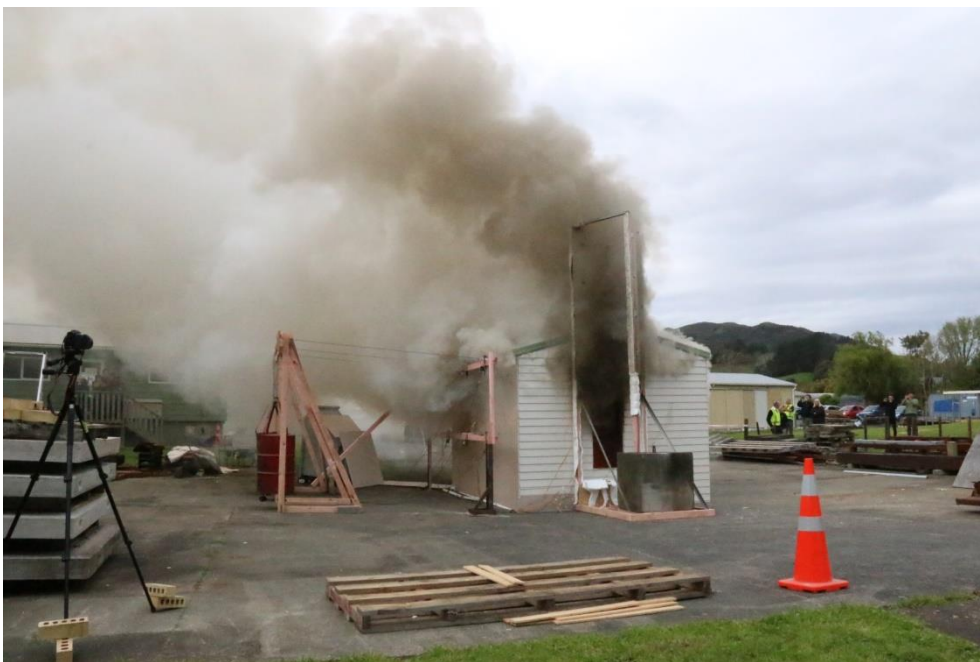
Figure 6-50 - Experiment #2, view of the free end wall after ceiling failure, $t \approx 14$ min

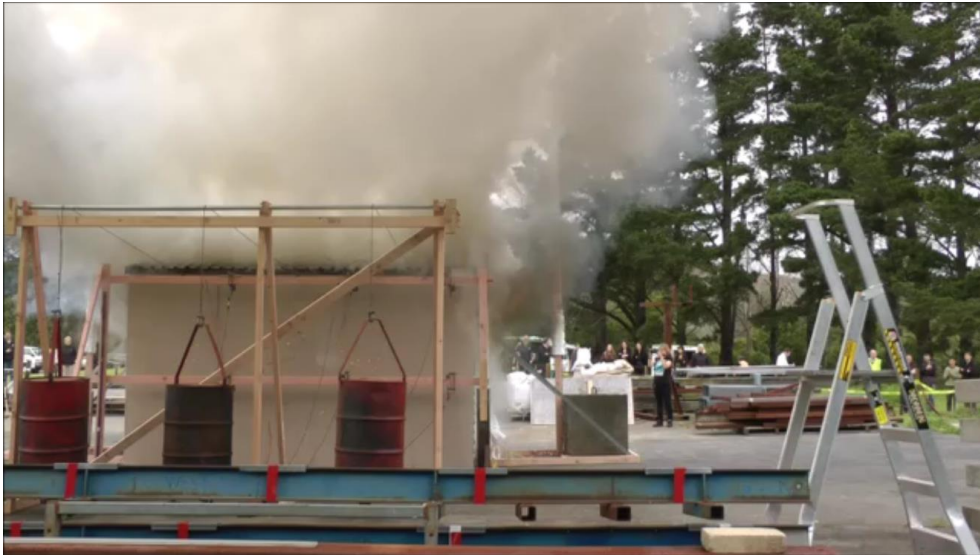
Figure 6-51 - Experiment #2, view of fire-rated wall after 15 min

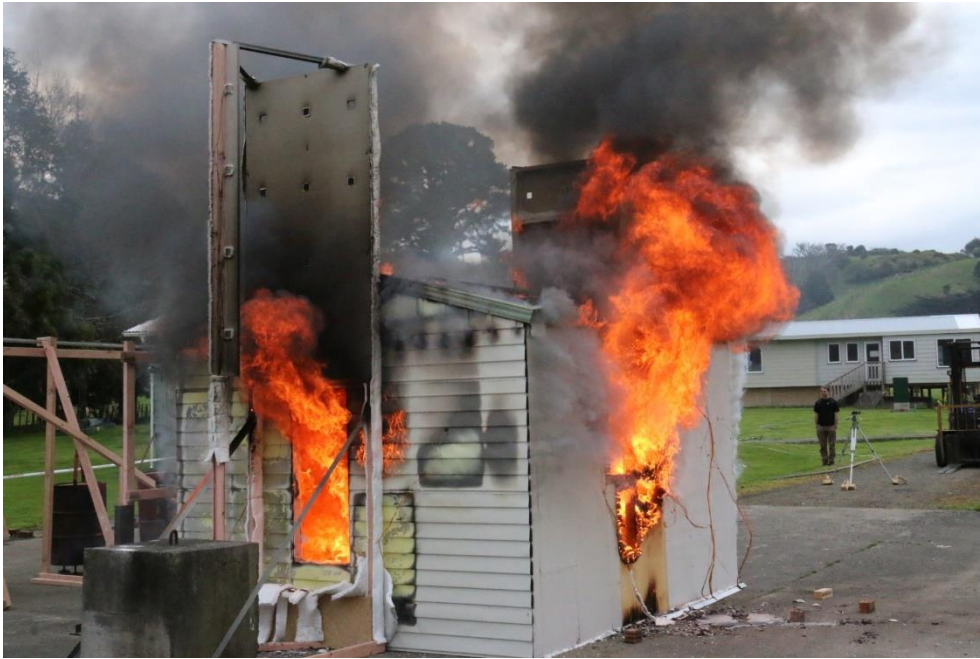
Figure 6-55 - Experiment #2 photo of non-rated long wall and free end wall after plywood failure, $t \approx 28$ min

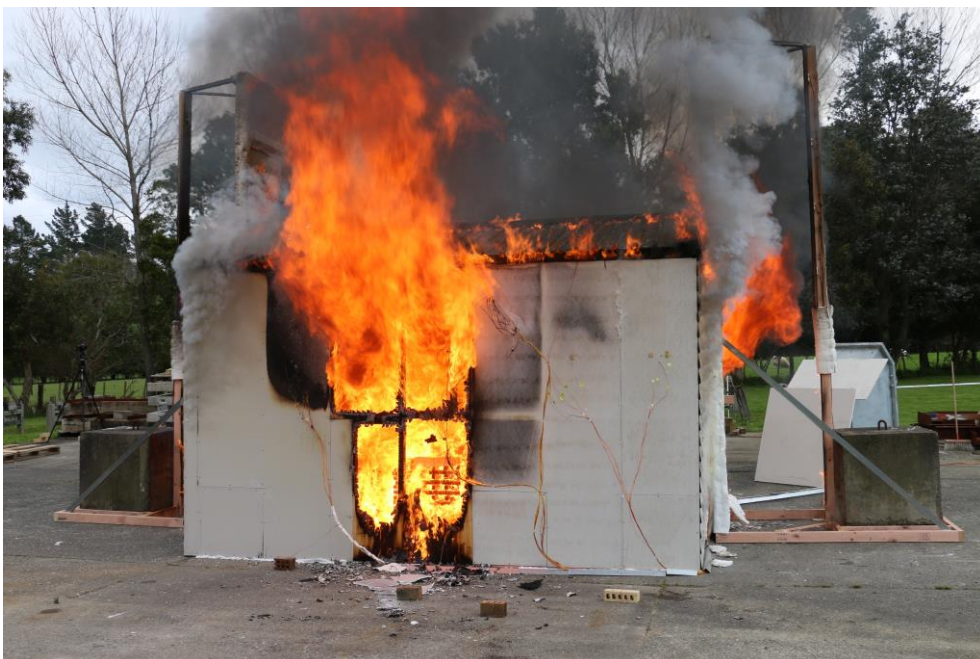
Figure 6-56 - Experiment #2, view of non-rated long wall after plywood failure, $t \approx 28$ min

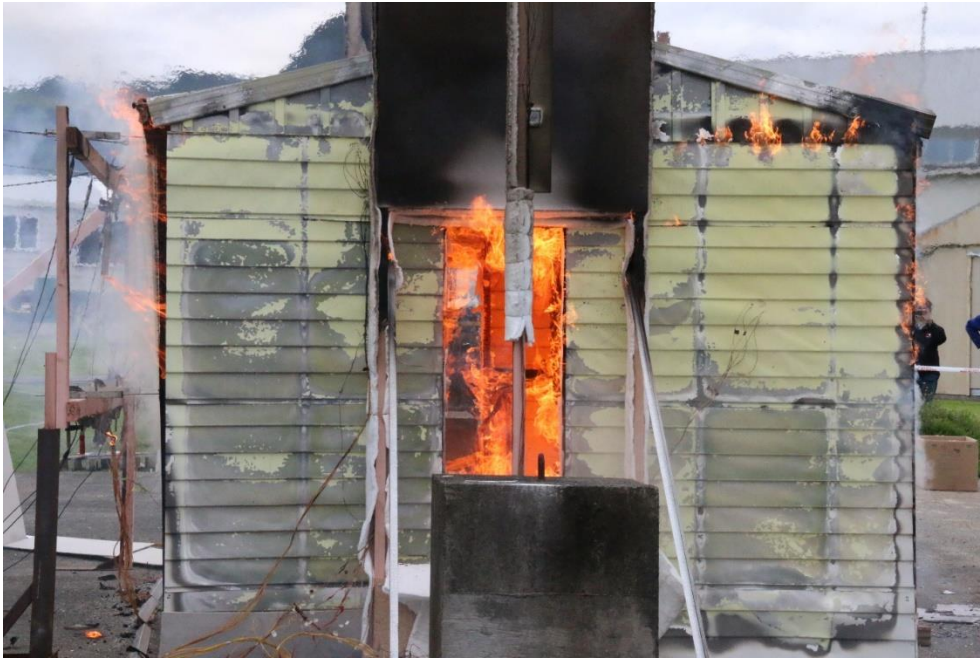
Figure 6-57 - Experiment #2, photo of free end wall (approx. 29 min) after fire-rated wall failure, visible on left of photo

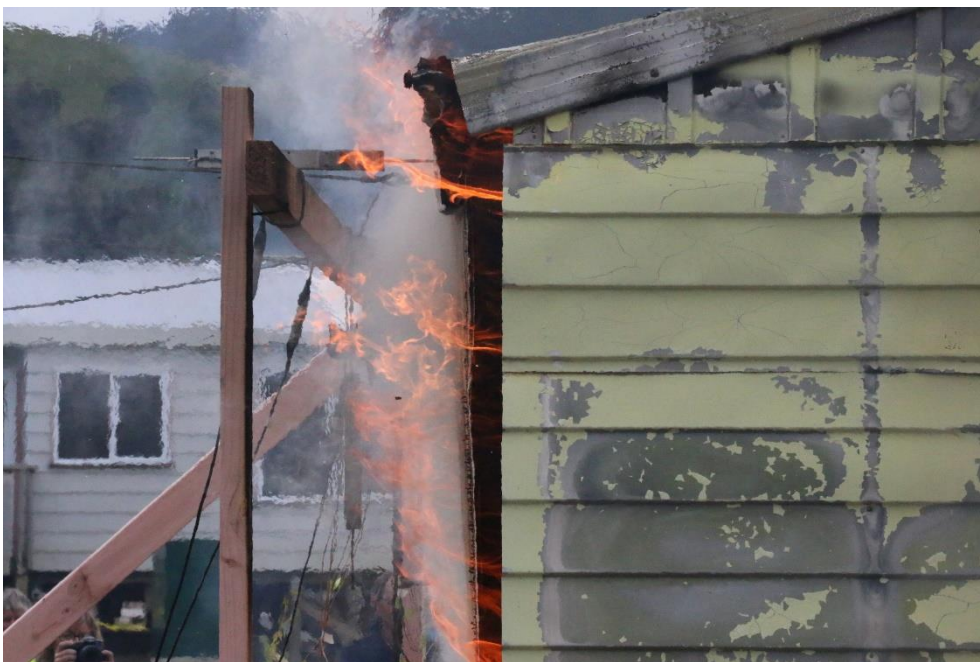
Figure 6-58 - Experiment #2, photo of fire-rated wall free end after failure (approx. 29 min)

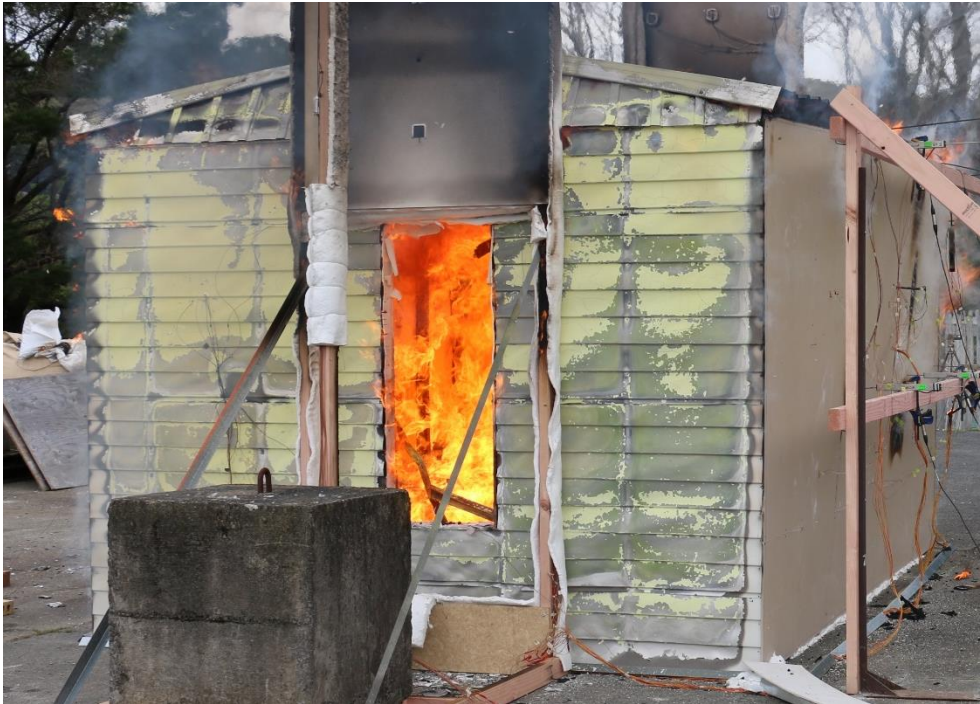
Figure 6-59 - Experiment #2, photo of fire-rated wall after failure (approx.31 min)

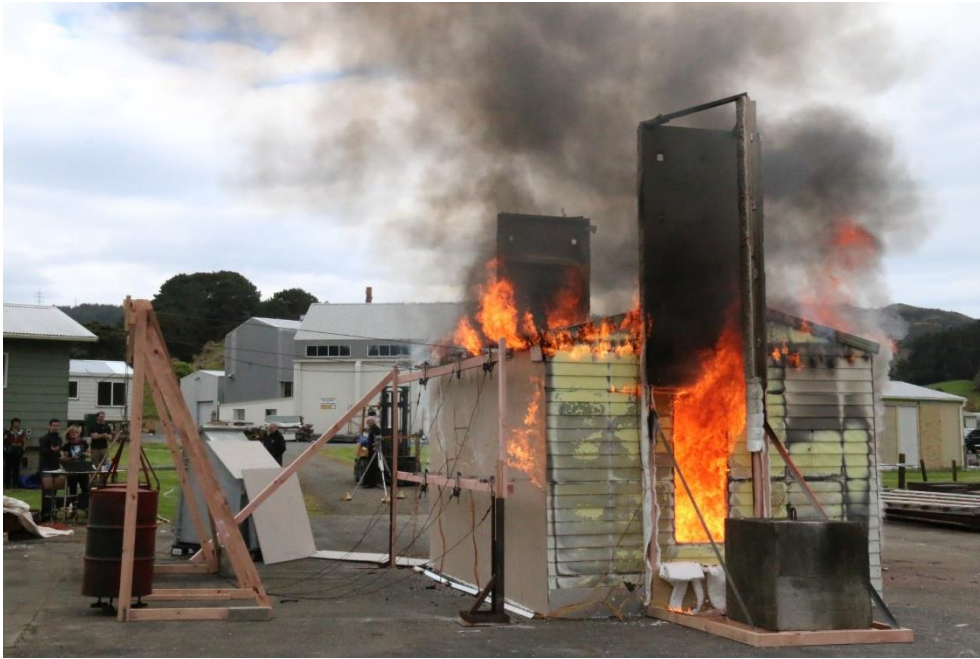
Figure 6-61 - Experiment #2 view of fire-rated wall and free end wall after failure under lateral load, $t \approx 30$ min

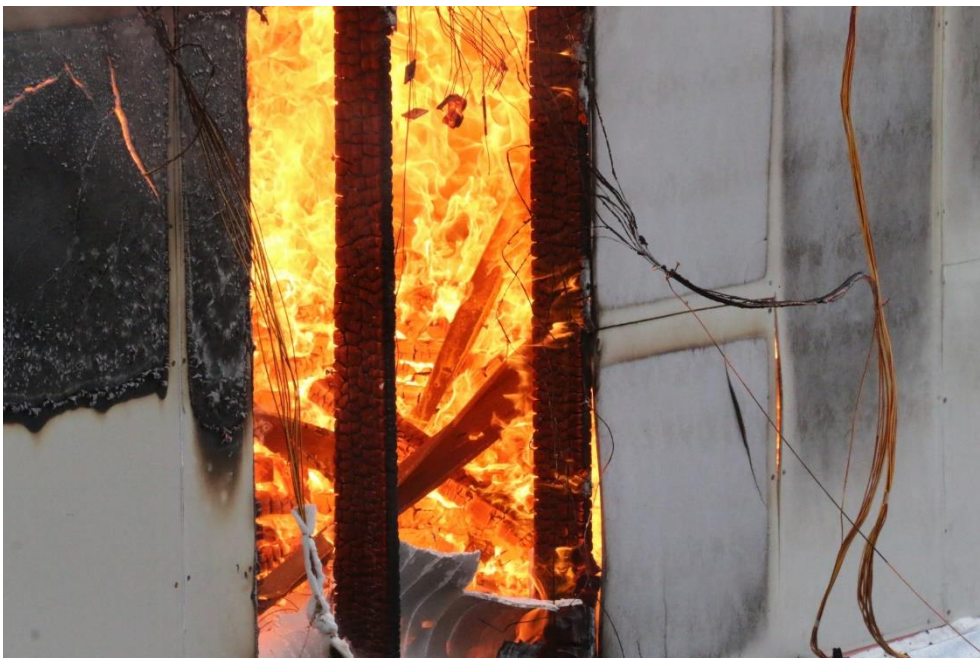
Figure 6-62 - Experiment #2 photo of opening in non-rated long wall where plywood cladding has failed, $t \approx 32$ min

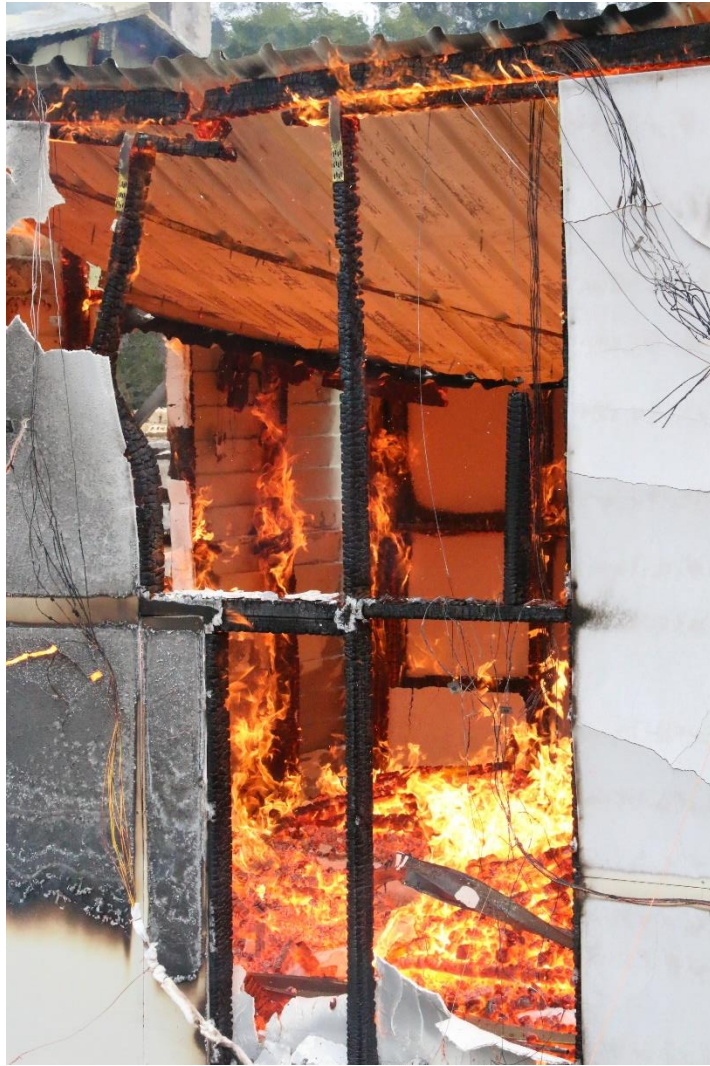
Figure 6-63 - Experiment #2, photo looking into compartment from plywood opening, $t = 35$ min
